Observations on the existing Ottoman mosques in Albania

Edmond MANAHASA¹, İlknur AKTUĞ KOLAY²

Abstract

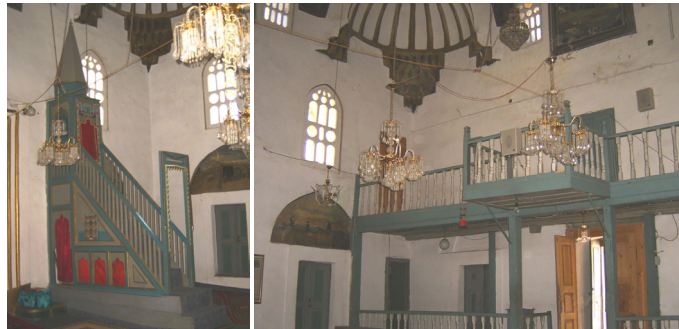
Figure 2. (a) The minber and (b) the women's gallery of the Mirahor İlyas Beg Mosque in Korçë.

The mihrab niche of the mosque with muqarnas rows at the top is adorned with golden gilded and framed by two golden-gilt frames with a rectangular profile. The wooden minber of the mosque is constructed on a wooden base raised from the ground with two steps (Figure 2a). The podium of predication used for the Friday sermons is placed in the north-east wall of the mosque and rests on a white washed half conic console. The podium ends with a wooden balcony.

The women's gallery of the mosque is a narrow wooden balcony along the north-western wall of the prayer hall. The middle part of this structure has a console rectangular balcony protruding into the prayer hall (Figure 2b). The protruding balcony of the women's gallery is found in 19th century Ottoman mosques; therefore, the gallery of the mosque must be a work of Dervish

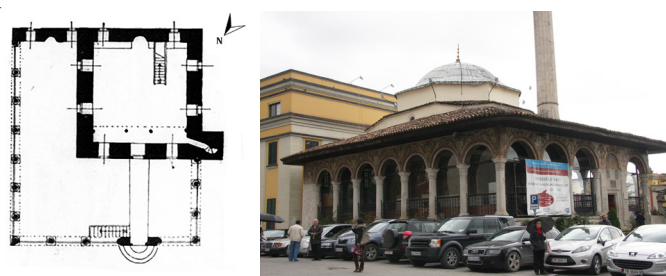
Figure 8. The plan (Meksi and Frasheri: 1977) and general view of the Haxhi Et-hem Beg Mosque from Skenderbeg Square in Tirana (Şükrü Sönmezer).

The mosque is built over a platform of approximately 0.80 m. higher than the ground level. The prayer hall of the mosque has a single domed square plan scheme with sides of 10.50 m. The transition element to the dome is squinch. The last prayer hall has an “L” form plan scheme covering the north-east as well as the traditional the north-west (entrance) façade of the prayer hall. Kiel (1990:251) suggests that the building must have been surrounded by other buildings and the site at that time was not suitable for the construction of the south-west wing of the last prayer hall. The last prayer hall is a wide one extending from the prayer hall at the entrance façade with three arched bays. It is covered by a tilted curb roof having an eave protruding approximately 1.00 m. At the north-west (entrance) façade there are 6 bays. The second bay from the right has piers with column like pilasters on the outer side and a door

frame in the inner side. The arch above the gate is a blind round arch. The last prayer hall has seven bays at the north-east and three bays at the south-west sides. All the bays consist of columns and round arches. The south-east façade of the last prayer hall is a wall with a mihrab niche on it. Just at the left of the last prayer hall gate there are stairs leading to the ablutions fountains of the mosque. The access to the last prayer hall is with four steps designed with a semicircular plan. The last prayer hall floors on both sides of the passage to the mosque are approximately 0.45 m higher (Figure 8).

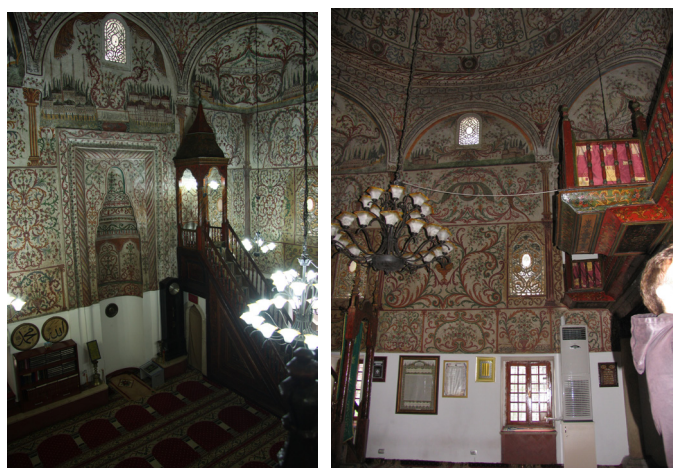
Figure 9. (a) the minber and (b) the interior of the Haxhi Et-hem Beg Mosque in Tirana.

en-gilt arch. The preacher's platform of the minber has a wooden baldachin which is surrounded by a cornice and covered with a pyramidal cap crowned by a crescent (Figure 9 (a)).

The wooden women's gallery covers the entrance side of the payer hall and is supported by two marble columns which are adjacent to the lateral walls. There is a small balcony protruding at the middle part of the women's gallery with a rectangular plan. The access to the gallery is from the stairs of the minaret which has the entrance from the prayer hall and thus must have been constructed at the same time as the mosque (Figure 9 (b)).

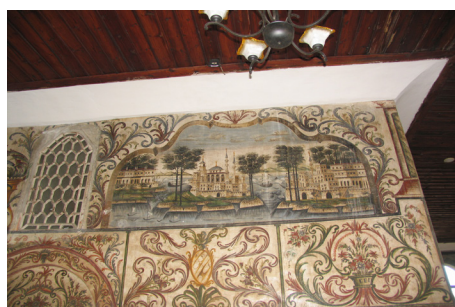
Figure 10. An imaginary scenes on the last prayer hall of the Haxhi Et-hem Beg Mosque in Tirana.

The interior walls of the mosque and the walls of the last prayer hall have wall paintings of mosques, city scenes and landscape as well as floral decorations (Figure 8 (a) and (b)). At the prayer hall, the wall paintings begin from the upper level of the first row windows. The paintings are placed in rectangular frames and continue all around the interior walls (Figure 9 (b)). On the walls there are three, on the transition zone one and on the dome three rows of paintings, perhaps symbolizing the seven levels of the Heaven. Most of the decoration consists of floral motifs. Beside the floral decoration at the transition zone row there are scenes of imaginary Ottoman mosques, palaces, towns and landscape pictures. At the last prayer hall, the wall paintings are on the walls of the building and on the walls above the arches of the rivaq on the façade. On the walls it begins above the lower row windows as two rows. Here also, the scenes of imaginary Ottoman mosques, palaces, towns and landscape pictures are placed in the floral motifs (Figure 10).

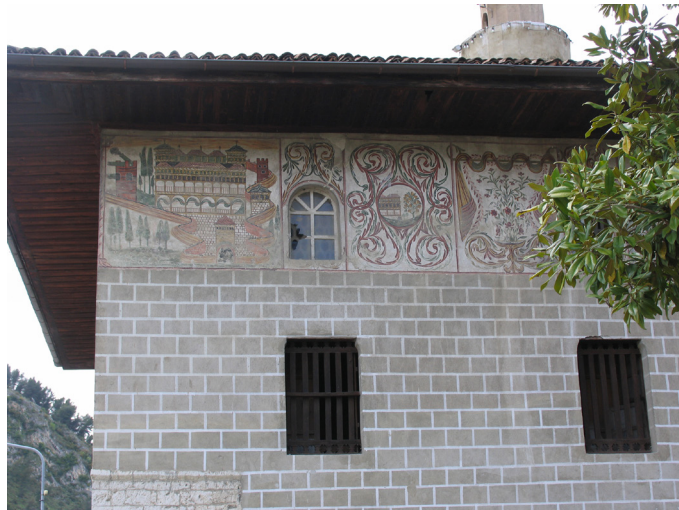
Figure 12. Wall paintings on the façade of the mosque of Beqarëve in Berat.

The wall paintings are at the façade, in the prayer hall and in the last prayer hall of the mosque. The scenes of imaginary Ottoman mosques, palaces, towns and landscape pictures take place in the floral decoration in rows

(Figure 12). Uçar refers to the architectural paintings as imaginary Istanbul scenes (Uçar, 2013a:1173).

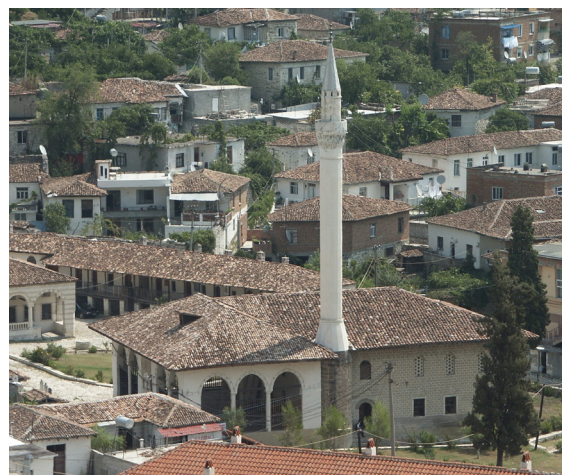
Figure 13. The plan (Kiel: 1990) and a general view of the mosque of Bayezid II in Berat.

The prayer hall of the mosque is a rectangle of 16.85 x 13.95 m., approximately the same as given by Evliya Çelebi (1999: 693) who mentioned 50 x 60 feet. (Figure 32). Two large domes at the center and four octagonal (close to an elliptic form) smaller domes on each side cover the hall. The domes are inset domes constructed of wood covered by a curb roof, which is supported by two wooden posts in the hall. The base of the minaret protrudes from the west corner and a wall of the same size where the landing of the women's gallery's stair rests protrudes from the east corner of the building. The last prayer hall covers the north-west façade of the mosque along both ends of the base of the minaret and the protruding wall on the opposite side. It is a wide space in three aisles. The pitched tilted roof of the last prayer hall is supported by round arches resting on "L" shaped piers and columns in between. There are two mihrab niches on its wall. (Figure 13).
